**PETER LACZKO PTY LTD**

**Metallurgical Services**

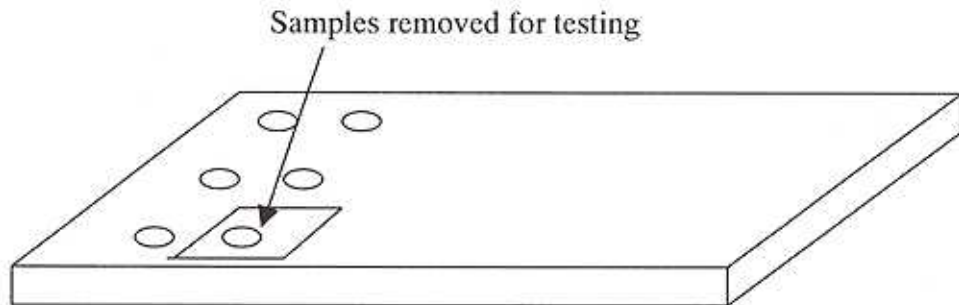
This surface polished down 0.5 mm for metallographic examination

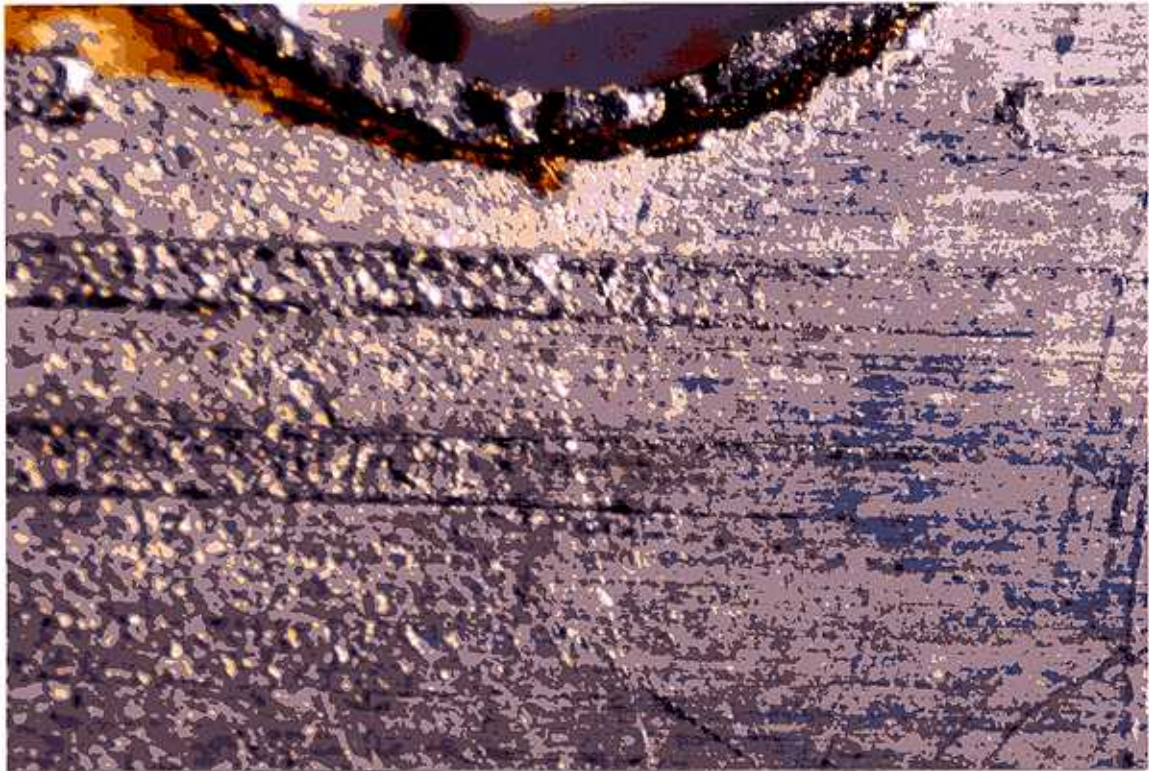
Fig 1 288 Hole #1. Optical stereomicroscope image showing the crack reaching into the mark left by the sensor cavity. The crack is very difficult to see. (X 20)

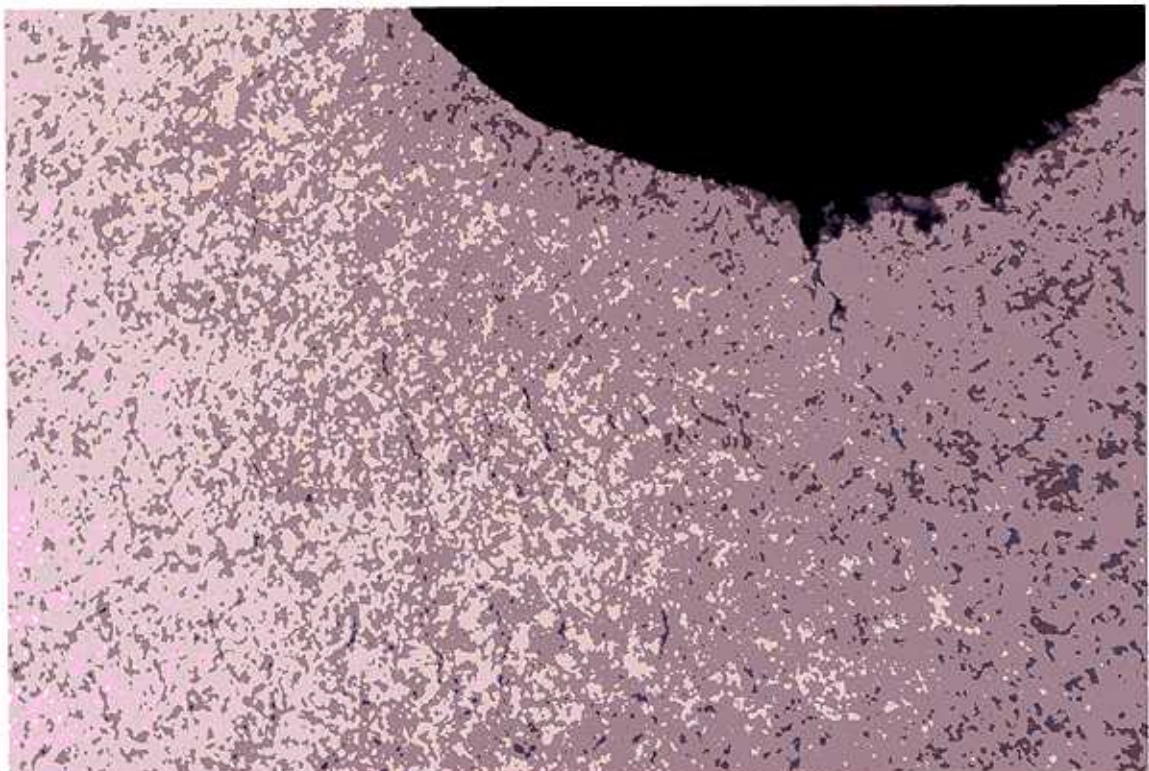
Fig 2 Same sample after very light polish and etching. Note the crack is clear and the craze cracking can be seen. (X 20)

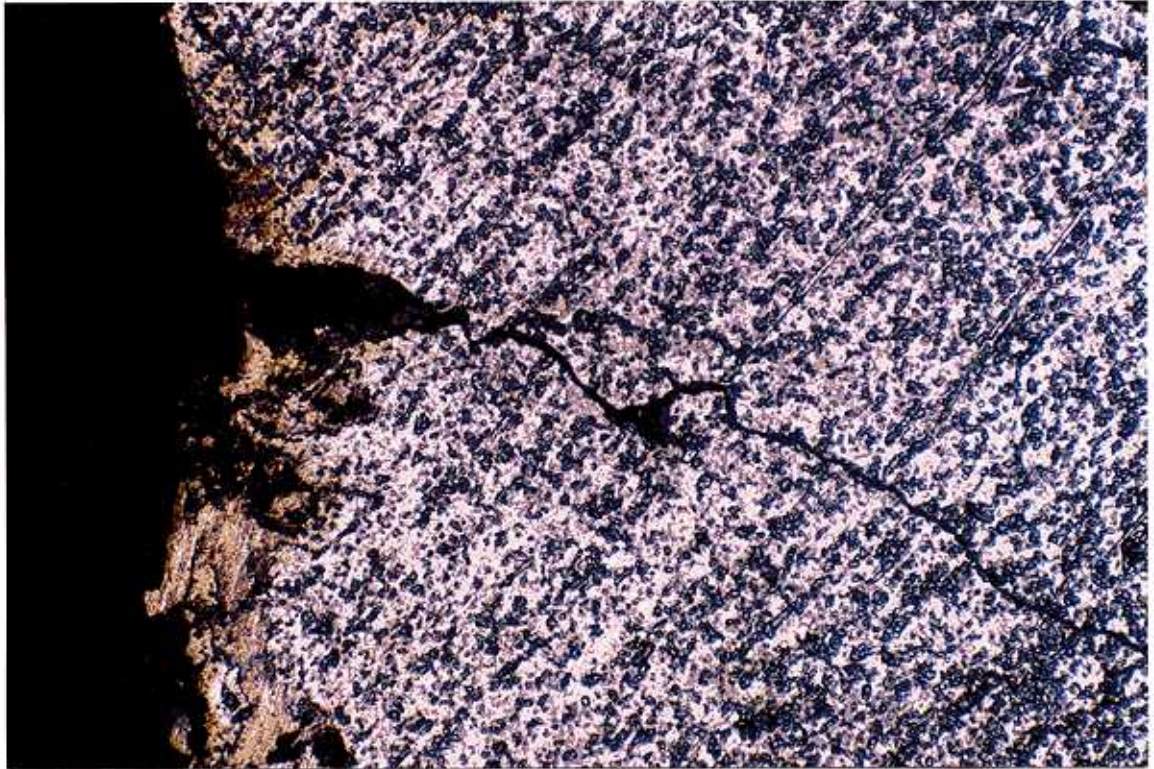
Fig 3 288 Hole #1. Micrograph showing the major crack.

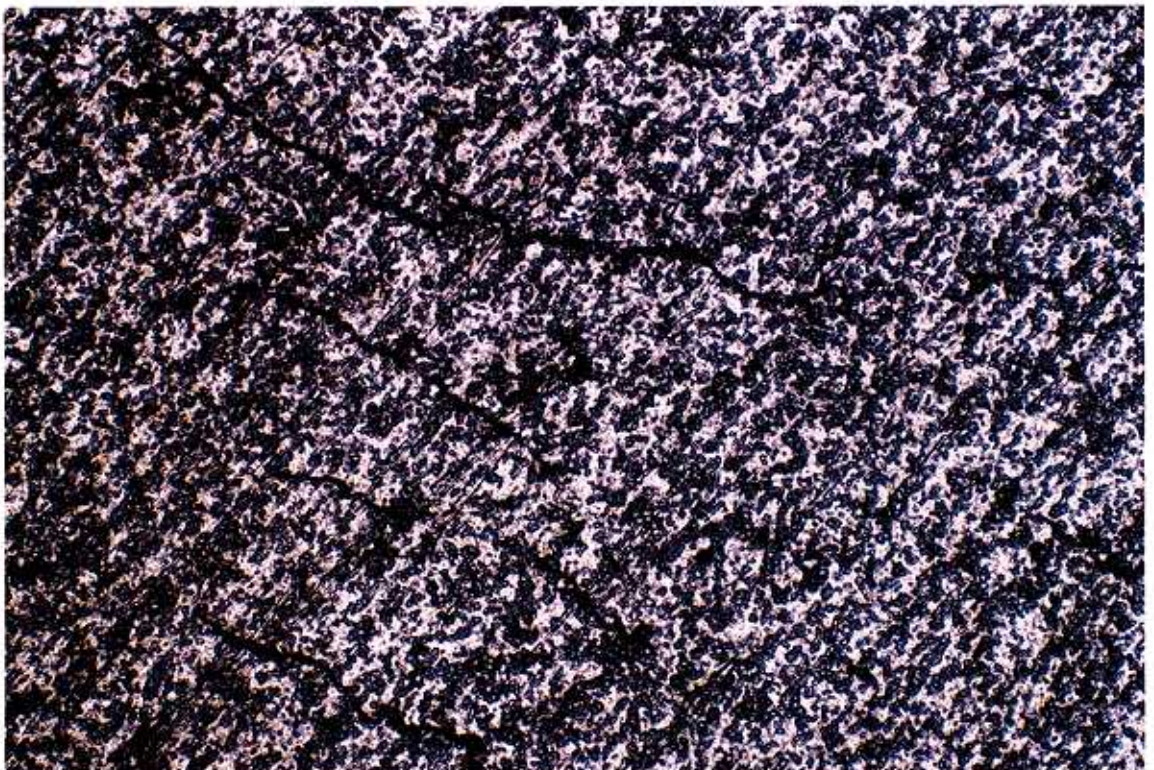
Fig 4 288 Hole #1 Shallow surface craze cracks near the hole after light polishing and etching. Compare with the SEM images of the rippled surface.

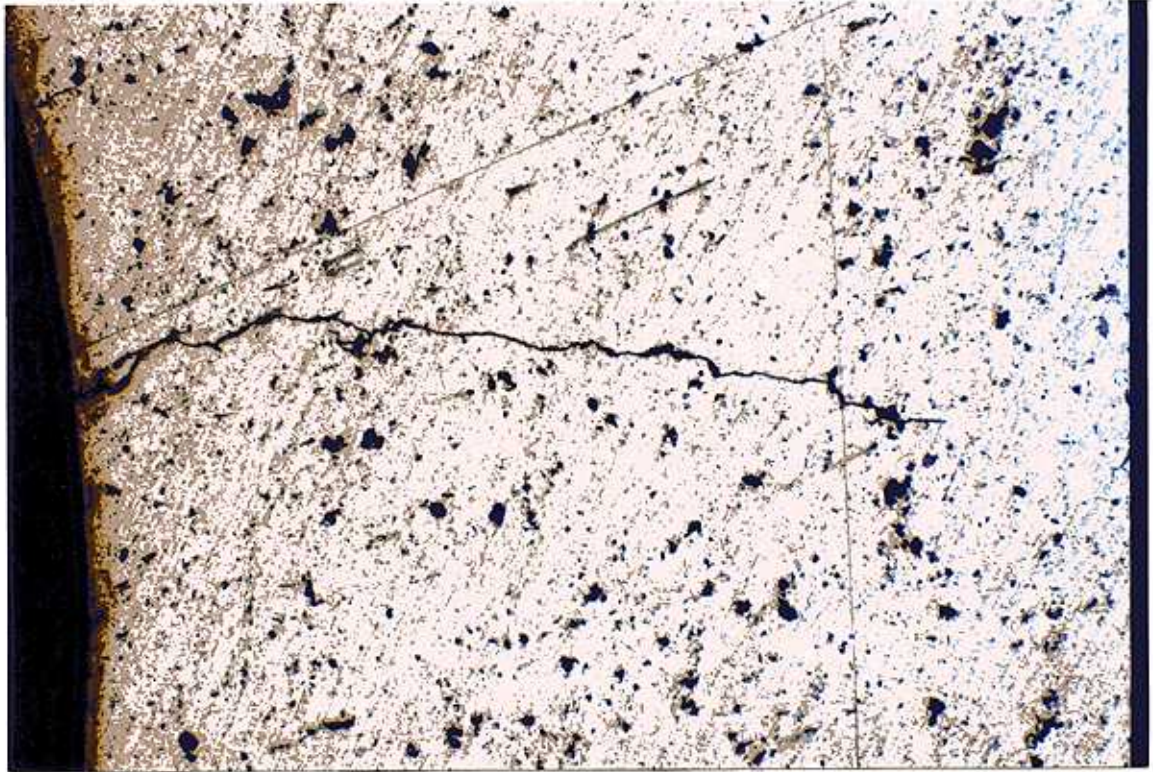
Fig 5 288 Hole #1. Photomicrograph after removing 0.5 mm from the surface of the plate, polishing and etching. Compare with fig 3. (X 100)

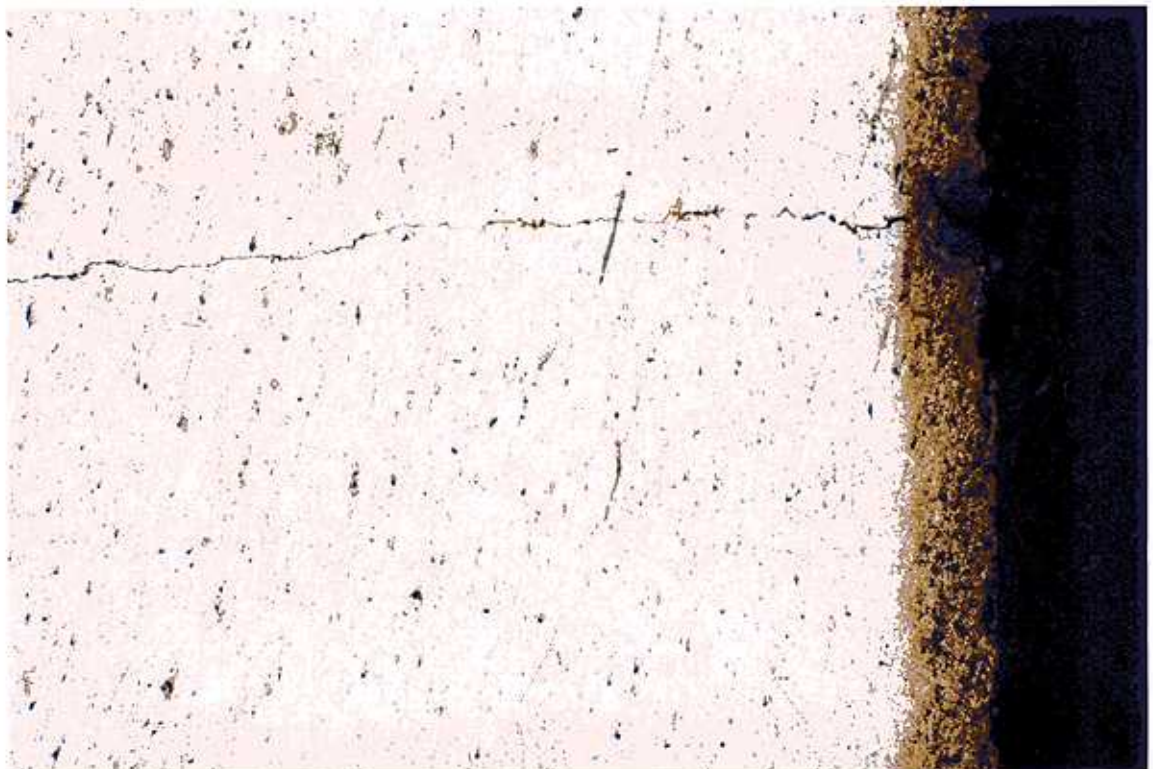
Fig 6 288 Hole #1. Polished section along the hole surface, the crack was 2 mm deep. (X 100)

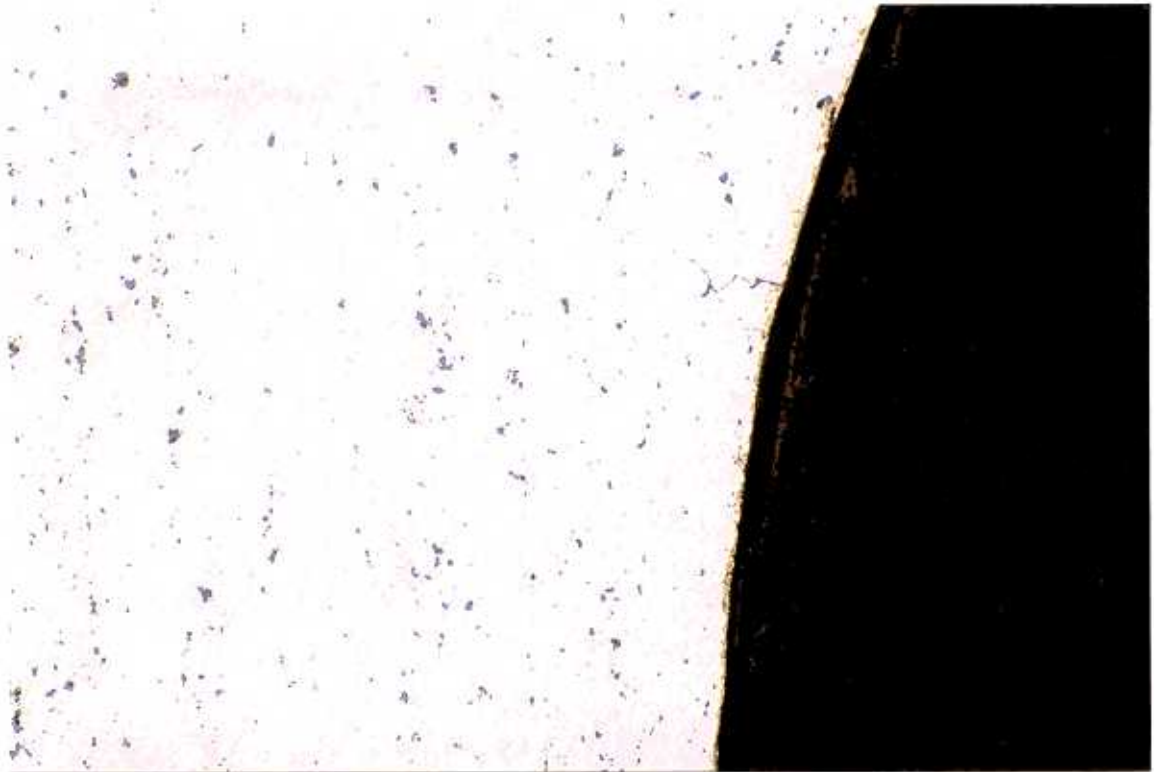
Fig 7 289 Hole #2. Optical stereomicroscope image showing the small crack at the hole edge. (X 100)

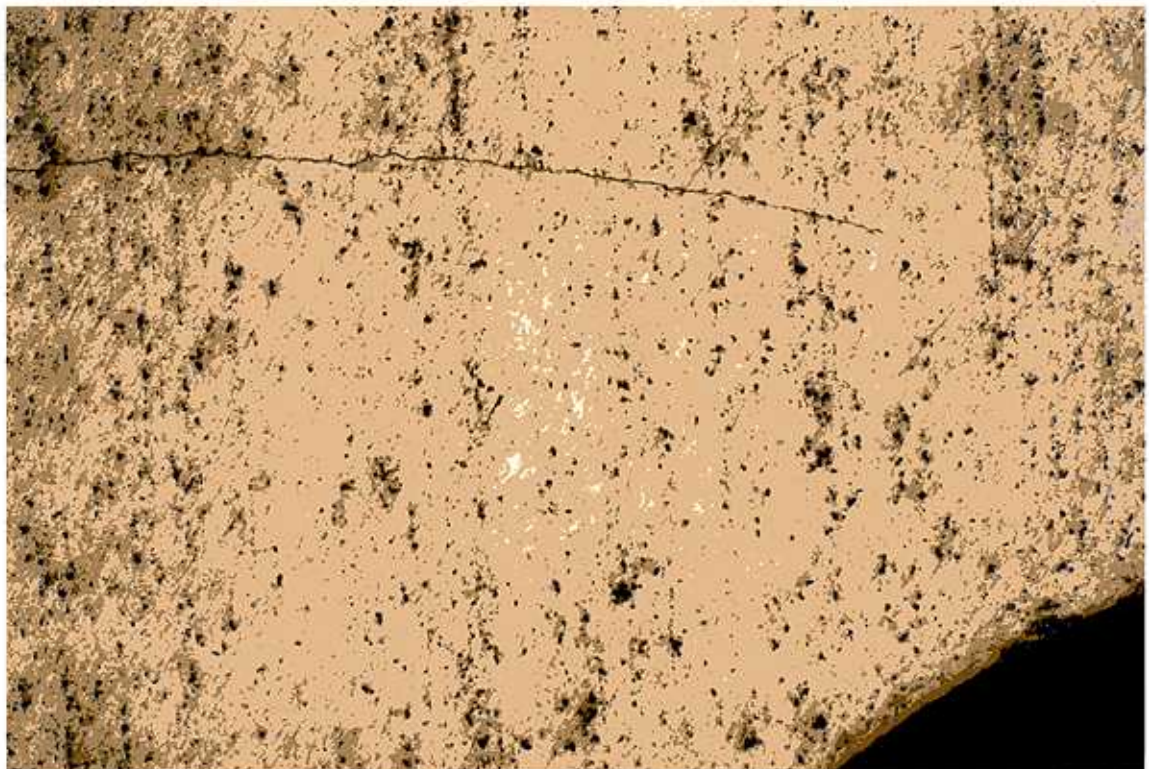
Fig 8 289 Hole #2. 3 mm crack remote from the hole. (X 100)

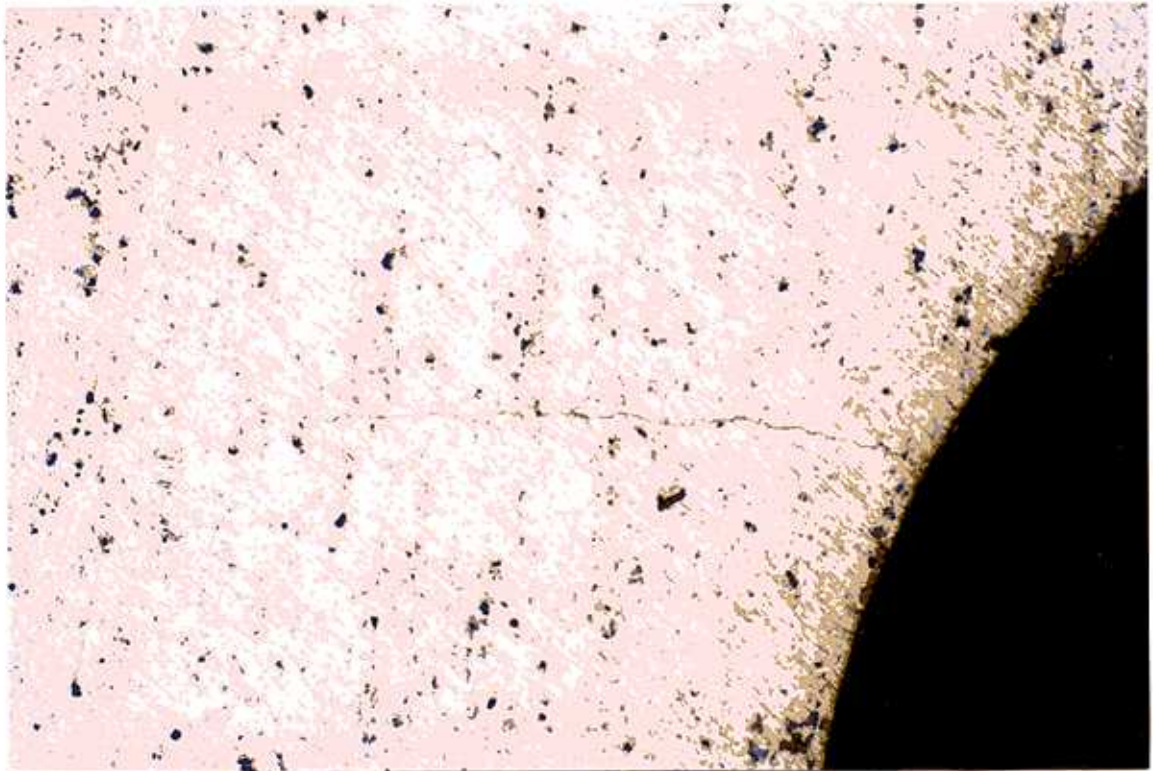
Fig 9 287 Hole #1. Crack extending from the hole edge.

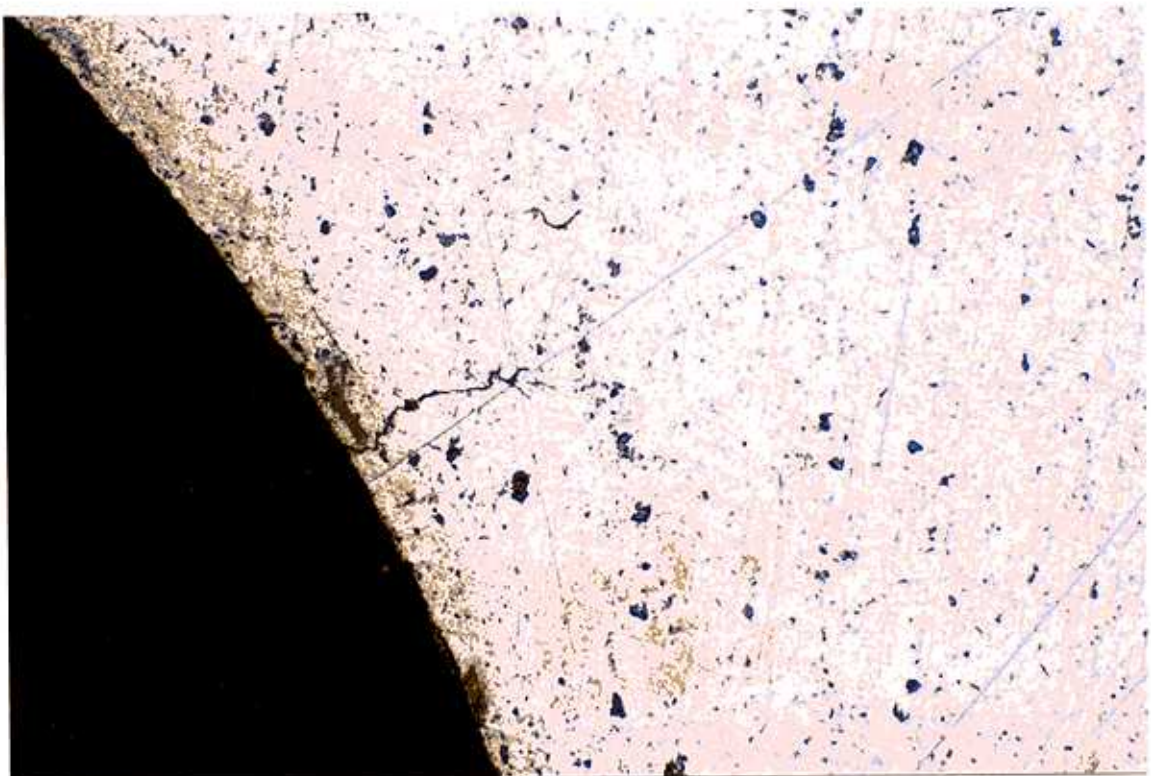
Fig 10 288 Hole #2. Small crack extending from the hole edge.

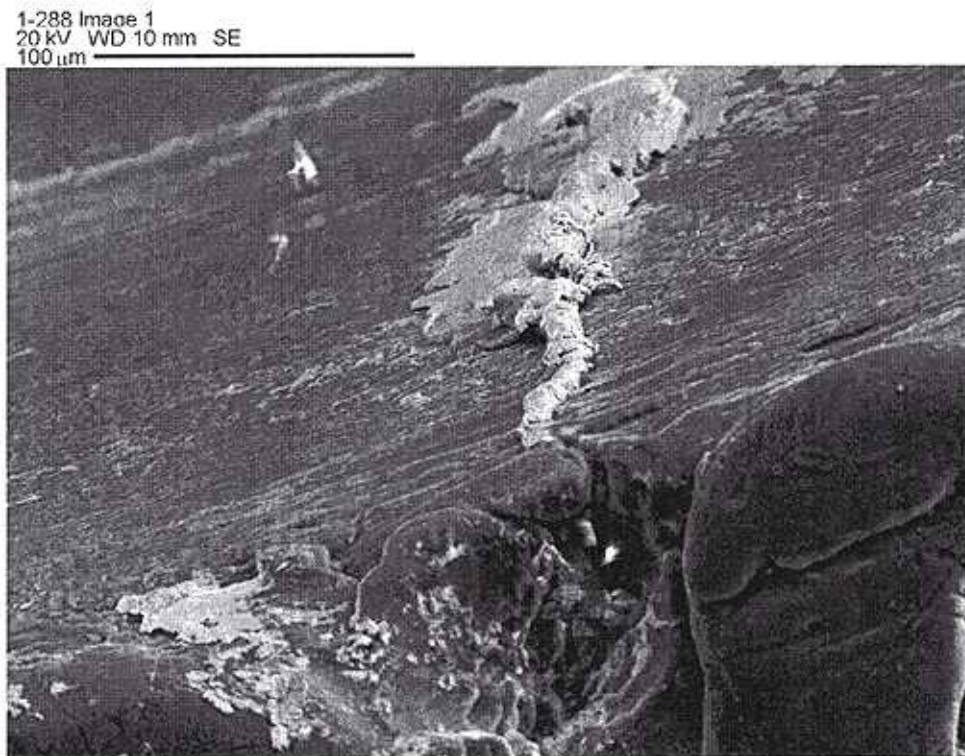
Fig 11 288 Hole 1 SEM image of the hole surface with material extruded from the crack

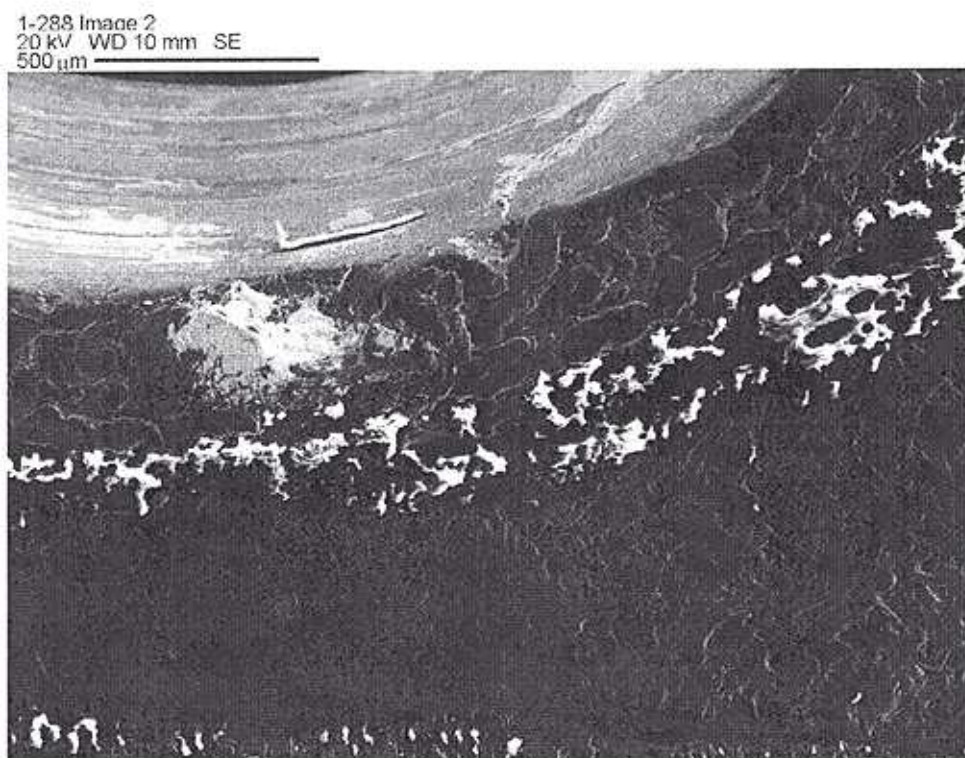
Fig 12 288 Hole 1 Lower magnification image of fig 11.

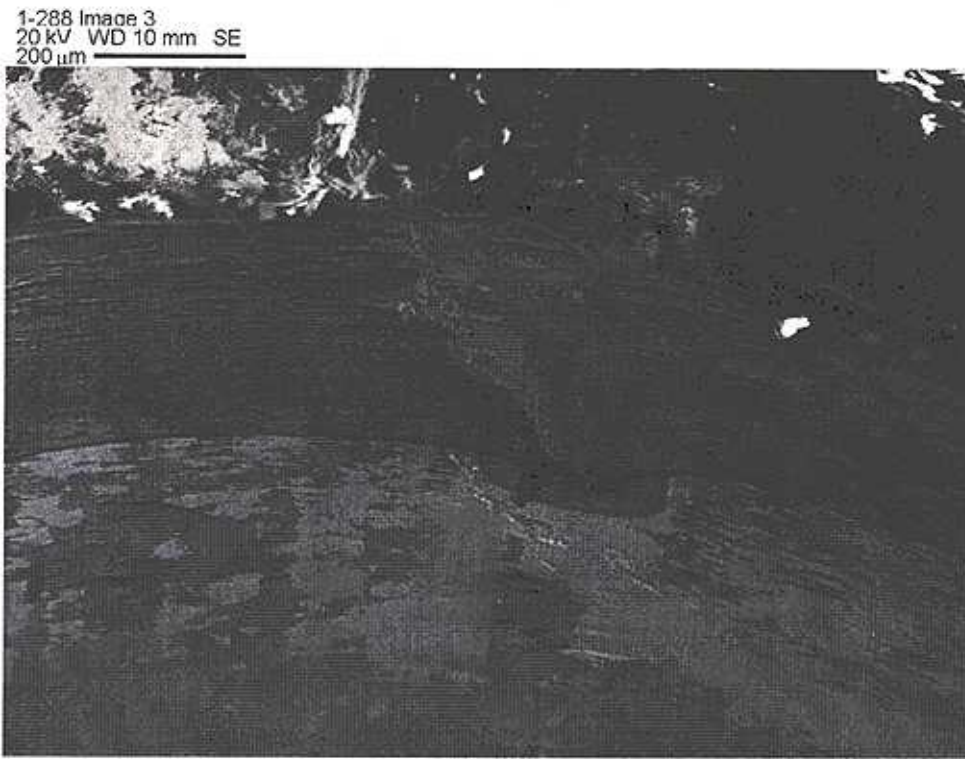
Fig 13 288 Hole 1 Crack on the other side of the hole.

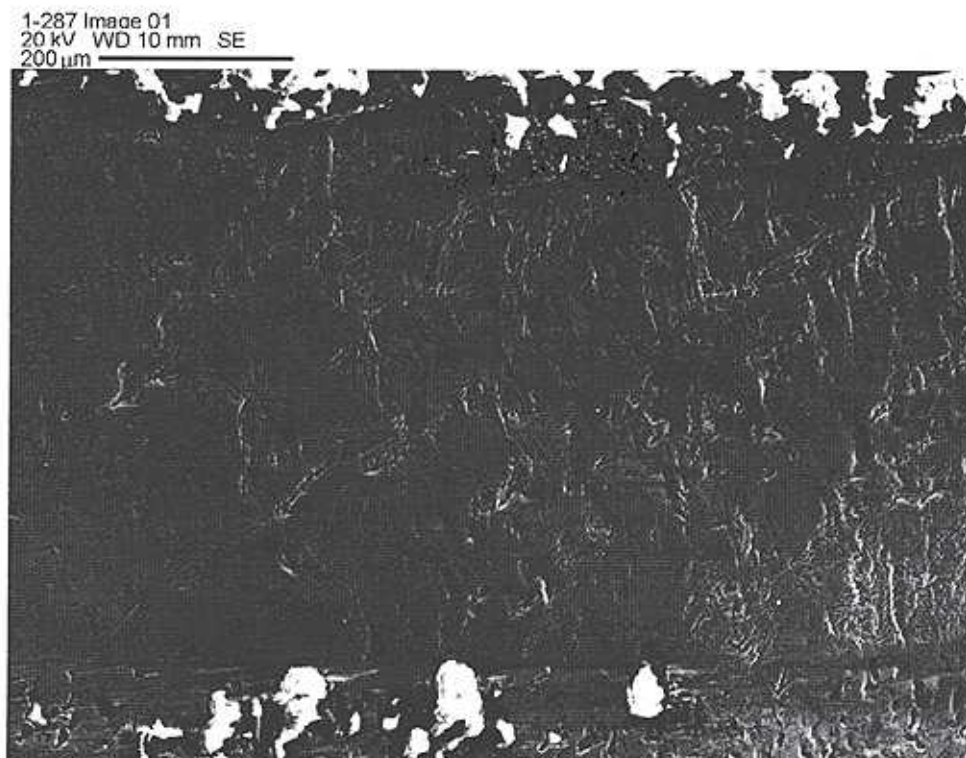
Fig 14 287 Hole 1 Surface ripples on the plate surface near the hole.

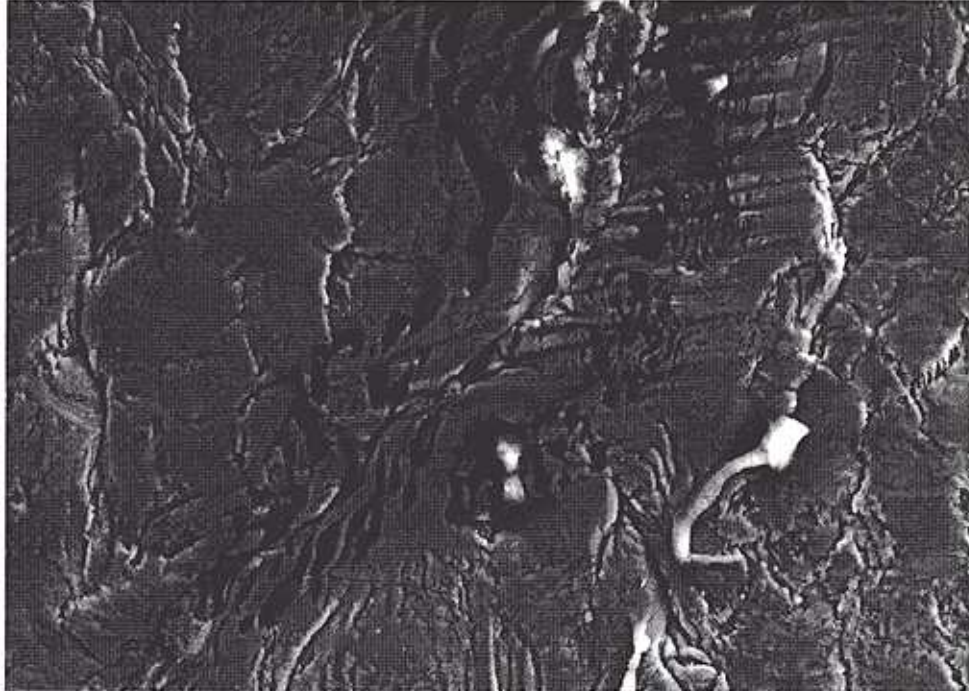
Fig 15 287 Hole 1 Surface ripples likely to be the main crack.

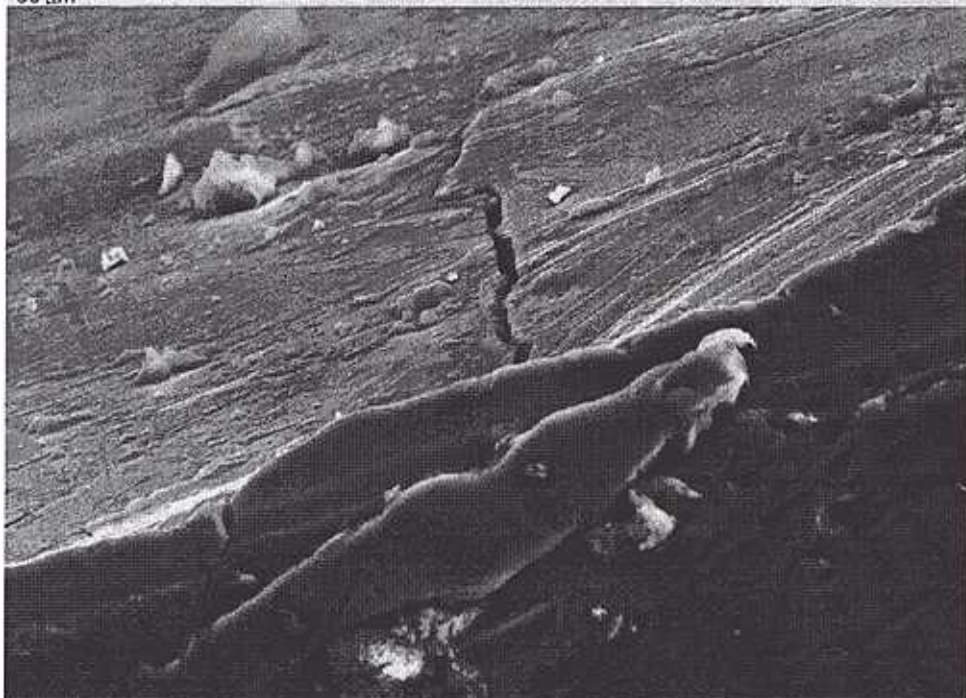
Fig 16 287 Hole 1 The crack has opened up on the hole surface.
