Evaluation of A Novel NDE Technique for Surface Monitoring using Laboratory Fatigue Specimens

P.K. Sharp and G. Clark¹

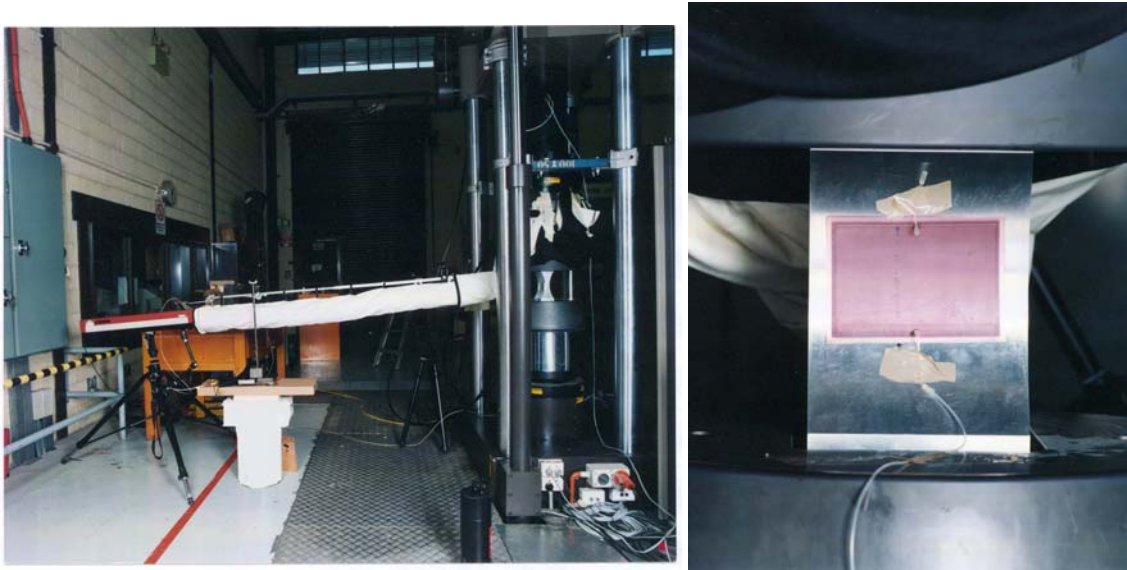
Figure 1: Large specimen set-up with laser holography on rear-face (left) and CVM system sensor (right) on front face. The reason for the shroud is to reduce external light when holographic plates are being exposed.

The large specimen was tested in a computercontrolled 1MN test machine cycling at 3 Hz. After every spectrum block the test was stopped and the specimen was loaded to 50% of peak load. A holographic laser interferometry (HLI) image was taken and the CVM system checked to see if any cracks had been located. The front of specimen was monitored with the CVM system and the rear with the HLI system, although at the end of the test an HLI image was taken of both sides.

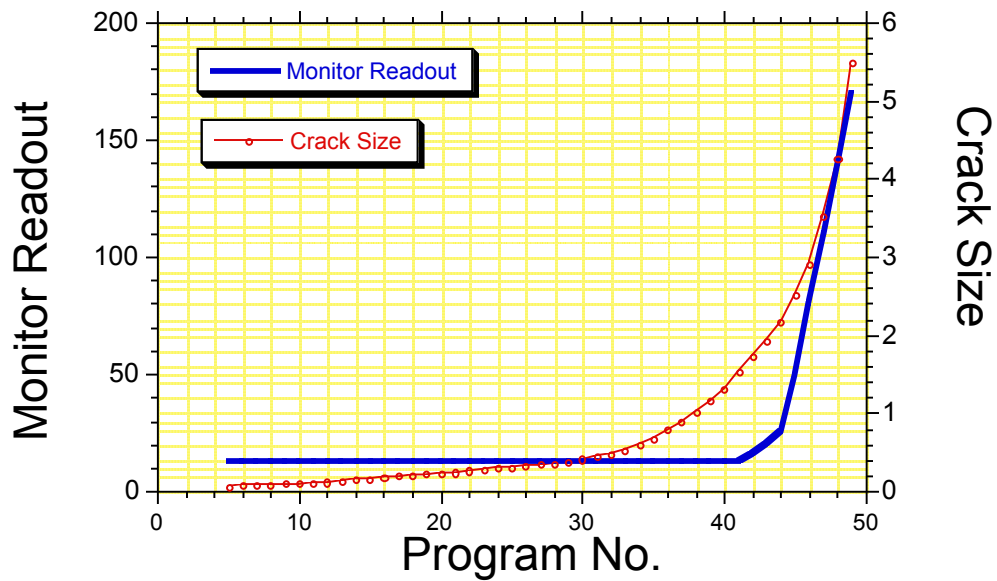
Figure 7: Plot of CVM system output (mB) versus crack depth(mm) per spectrum program number

The first specimen was used to generate a CVM output vs. crack depth curve. The specimen failed from a corner crack at the identified location, and the progress of the crack throughout the test was determined by quantitative fractography. Figure 7 shows the CVM response with number of programs, as well as the crack growth behaviour. Figure 7 suggests strongly that the CVM is responding in a fairly sensitive manner to crack growth, once the initial atmosphere/vacuum connection has been made.

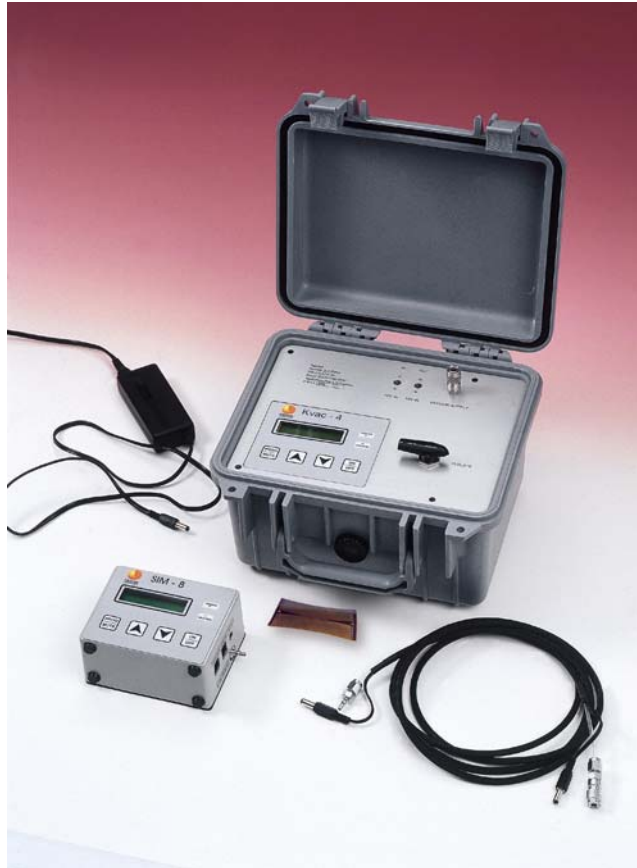
Figure 9: Comparative Vacuum Monitor System 2000 used for the high strain trials. The picture shows the larger field unit and the smaller laboratory unit.

The CVM system zero condition (under a range of loads from 0%-70% peak load) was very stable at around 5-10mV (0.3-0.5mB). The trigger level was set at 40mV (2mB). The CPG varied from 35mV at 0% peak load to 40mV at 70% peak load. The trigger level was set at 130mV. Each technique was providing real-time monitoring of the specimen. Once cracking was detected the gauge or sensor was removed and a magnetic rubber inspection (MRI) was performed to confirm the size and location of the cracks. It should be highlighted that the MRI was conducted with zero load on the specimen (simulate wing test conditions), not the more favourable pre-loaded condition.
