Air Safety Week®

Structural Monitoring Can Pinpoint Impending Failures

A new technology from down under is vacuuming up cracks

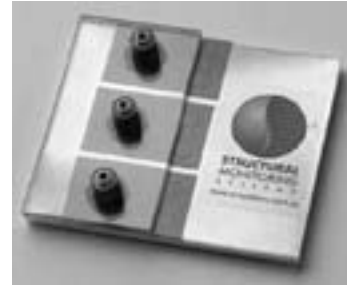
An integral sensor developed with Airbus and used by the manufacturer to detect cracks around rivet holes in repair schemes for GLARE, the aluminum-fiberglass composite used on the upper fuselage of the A380.

Of significance, based on damage under doublers found in the wreckage of the China Airlines plane, this technology could detect cracks under doublers. An integral sensor can be sandwiched between the doubler plate and the surface with the cracking problem (*see*
